SERVICE BULLETIN		
To:	All Dealers	Reference SB0285 Issued: 10th February 2009
For the attention of:	Service Manager/After Sales Manager	
Please copy to:	The Dealer Principal The Warranty Administrator Aston Martin Technician(s) The Parts Manager	
Model:	DB9 and DBS	
VIN Range:	All	Page 1 of 5
Subject:	Washer Reservoir and Motor Assemblies

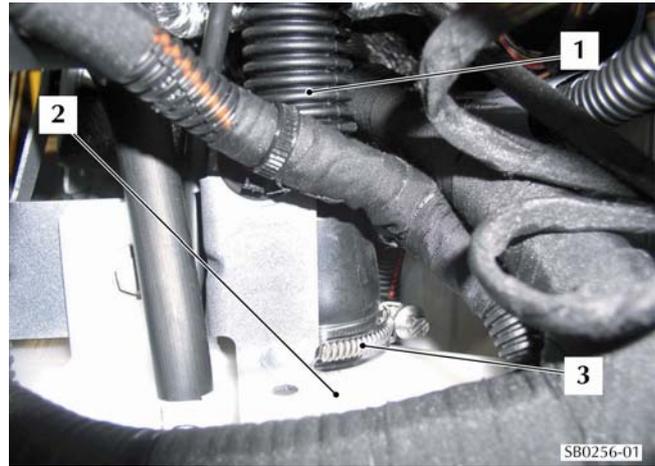
Figure 1

8. Examine the connection of the filler pipe (1) on the top of the reservoir (2). Make sure that it is correctly located onto the stub pipe of the reservoir (Refer to Figure 1).

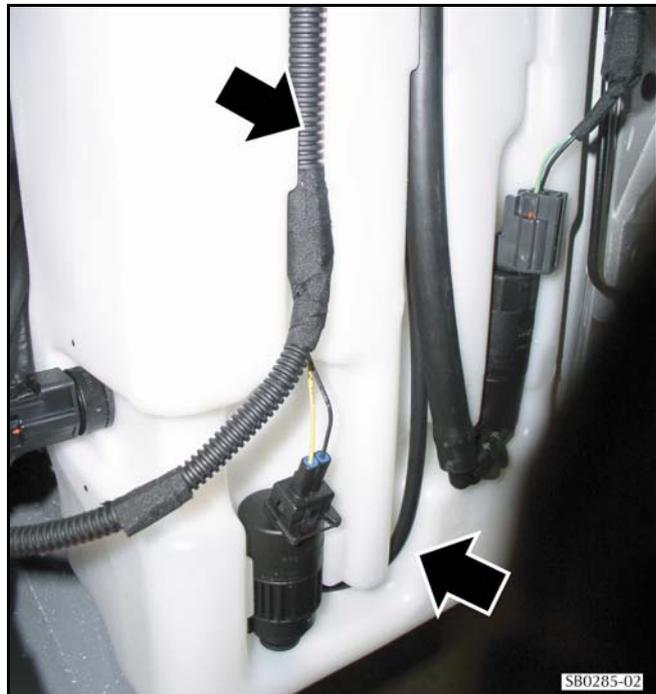
Figure 2

9. Make sure that the worm-drive clip (3) is tightened and correctly installed.
10. Make sure that the pipes and electrical cables are correctly routed and correctly held in position (Refer to Figure 2).

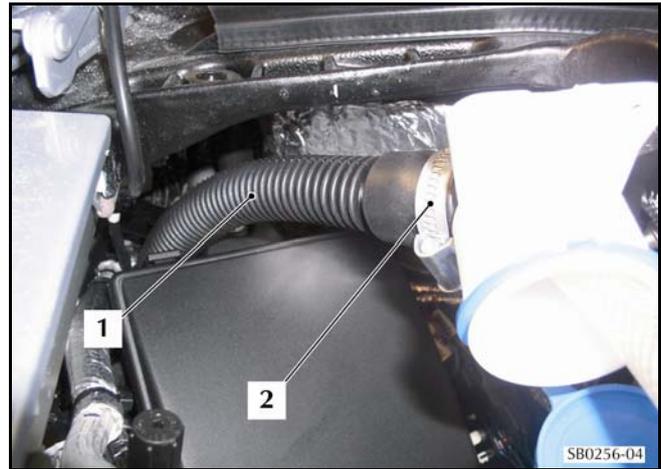
Figure 3

11. Examine the filler pipe. Make sure that it is not damaged and is correctly installed (Refer to Figure 3).

12. Make sure that the routing of the filler pipe (1) is correct.
13. Make sure that the worm-drive clip (2) is tightened and correctly installed.
14. Make sure that all of the hoses, pipes and electrical connection do not have too much tension.

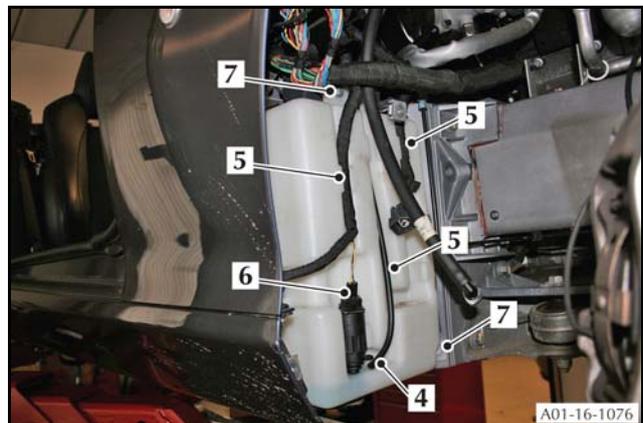
Figure 4

1. Release the tube (4) from the windscreen washer motor and drain the reservoir into an applicable container (Refer to Figure 4).

1. Disconnect the two clips that attach the battery harness to the bottom of the reservoir.
2. Move the harness away.
3. Disconnect the clip that attaches the harness for the level sensor to the reservoir.
4. Release the harnesses and the tubes (5) from the reservoir moulding.
5. Disconnect the electrical connector (6) for the windscreen washer motor.
6. Remove the M6 screw (7) that attaches the bottom of the reservoir.
